Phase II Environmental Site Assessment Report

Project No. 35107140
April 26, 2013

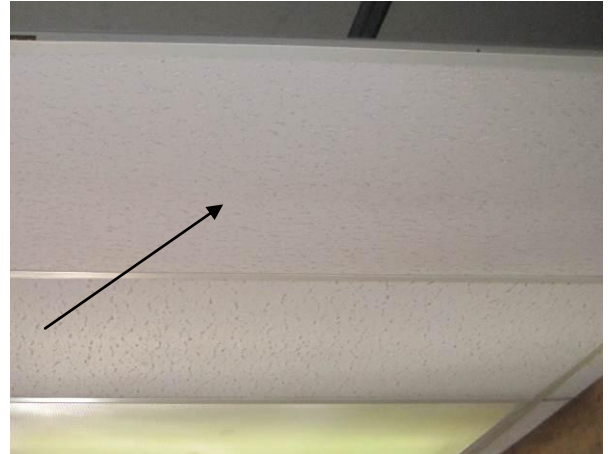
Photo #4 Asbestos-containing 2' x 4' Ceiling Tile (White, Pinholes, Lengthwise Fissures).

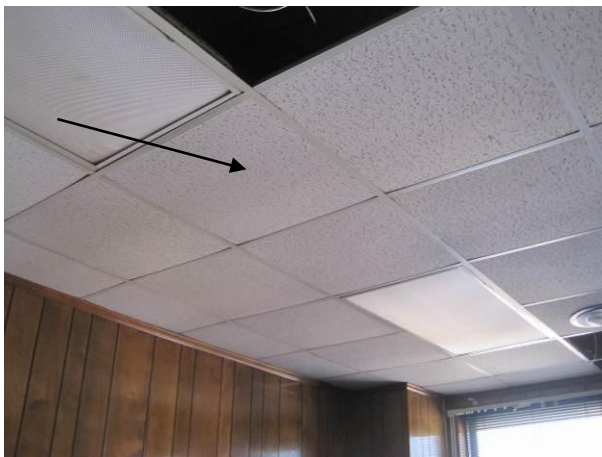
Photo #5 Asbestos-containing 2' x 2' Ceiling Tile (White, Pinholes, Fissures).

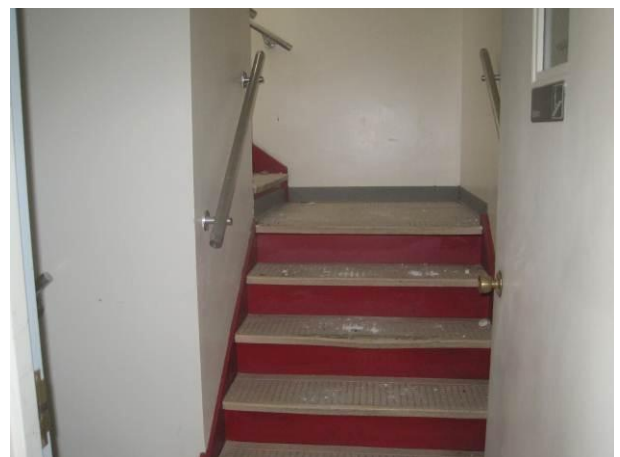
Photo #6 Asbestos-containing Ceiling / Wall Texture / Drywall / Joint Compound (Multicolor, Drag).
